Manhole Inspection Summary

Manhole # S710__013MH

Insp Date: **4/16/08 9:49 AM**

Location Address: **6719 Youngstown Ave.**

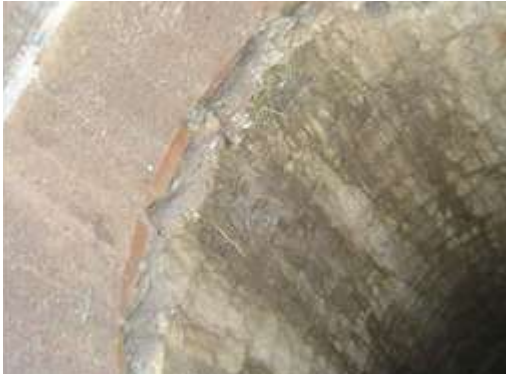
Defect 1

Condition: ☐ Sound ☐ Cracked ☐ Root Intrusion ☒ Loose Brick ☒ Deteriorated

loose bricks and missing mortar at frame seal

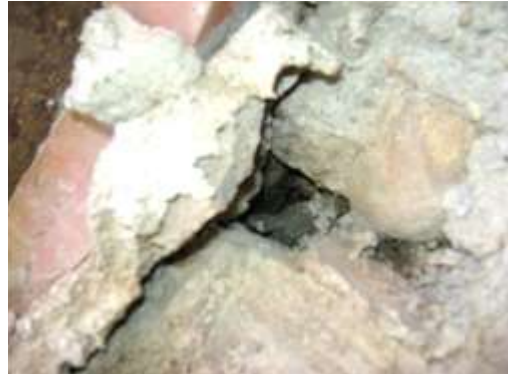
Defect 3

void in the mortar under the frame

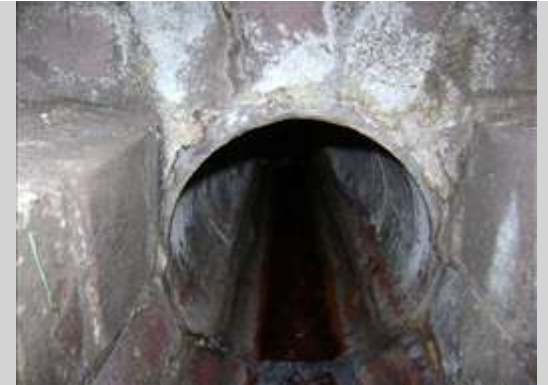
12 O'Clock Outflow

8 in. Circular Gravity Sewer
Pipe Out @ 12 O'Clock

Pipe Height: **8.4** (in.) Rod and Bar (Angled)
Pipe Material: **Clay** ☐ Pipe Lined
Invert Depth: **8.00** (ft.) Flow Characteristics: **Slow**
Deposits: ☒ None ☐ Mud ☐ Sludge ☐ Debris ☐ Grease
Silt Depth: (in.) Deposits Extent:
Infiltration: **None** Pipe Seal Cond: **Sound**

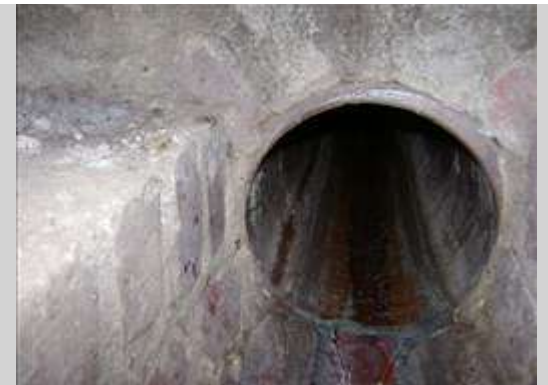
6 O'Clock Inflow

8 in. Circular Gravity Sewer
Pipe In @ 6 O'Clock

Pipe Height: **8.4** (in.) Rod and Bar (Angled)
Pipe Material: **Clay** ☐ Pipe Lined
Invert Depth: **7.83** (ft.) Flow Characteristics: **Slow**
Deposits: ☒ None ☐ Mud ☐ Sludge ☐ Debris ☐ Grease
Silt Depth: (in.) Deposits Extent:
Infiltration: **None** Pipe Seal Cond: **Sound**
